WETLAND DELINEATION / DETERMINATION REPORT COVER FORM

Wetland Delineation Report

Willamette Water Supply Program Cornelius Pass Pipeline Project (PLW 2.0)

January 2017

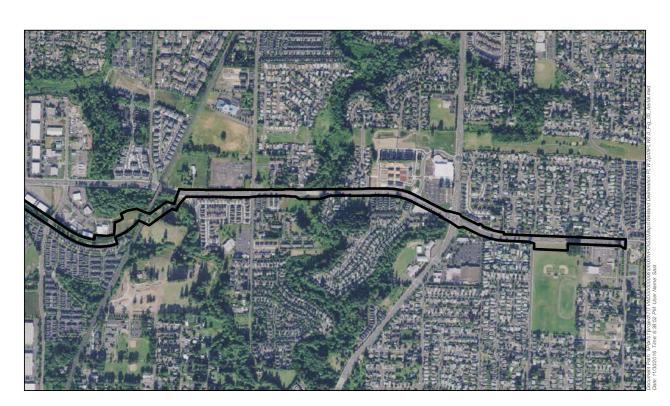
Figure 6, Sheet 1 of 9
Delineated Wetlands

On-site features (wetlands, ditches, streams, culverts, and data plots) were mapped with a Trimble Pathfinder GEO XH receiver with typical accuracy of 3 feet or better. Off-site boundaries are approximate and were mapped based on field review from adjacent public right of way and aerial photo interpretation. An asterisk was included where jurisdictional features, with the accusion or lupland diffress, extend off site. Only taxlots which intersect the study area are labeled. Imagery: USDA NAIP 2016; inset maps show Bing Maps Aerial imagery.

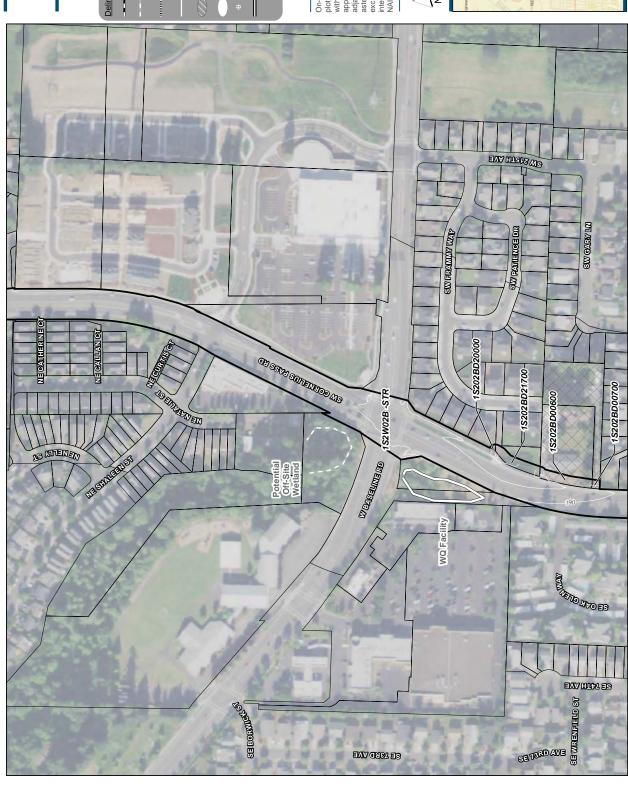
.W 2.0) Wetland Delinea Figure 6, Sheet 3 of 9 Delineated Wetlands

On-site features (wetlands, ditches, streams, culverts, and data plots) were mapped with a Trimble Pathfinder GEO XH receiver with typical accuracy of 3 feet or betate. Off-site boundaries are approximate and were mapped based on field review from adjacent public right of way and aerial photo interpretation. An asterisk was included where lurisdictional features, with the exclusion of upland ditches, extend off site. Only taxlots which intersect the study area are labeled. Imageny: USDA NAIP 2016; inset maps show Bing Maps Aerial imagery.

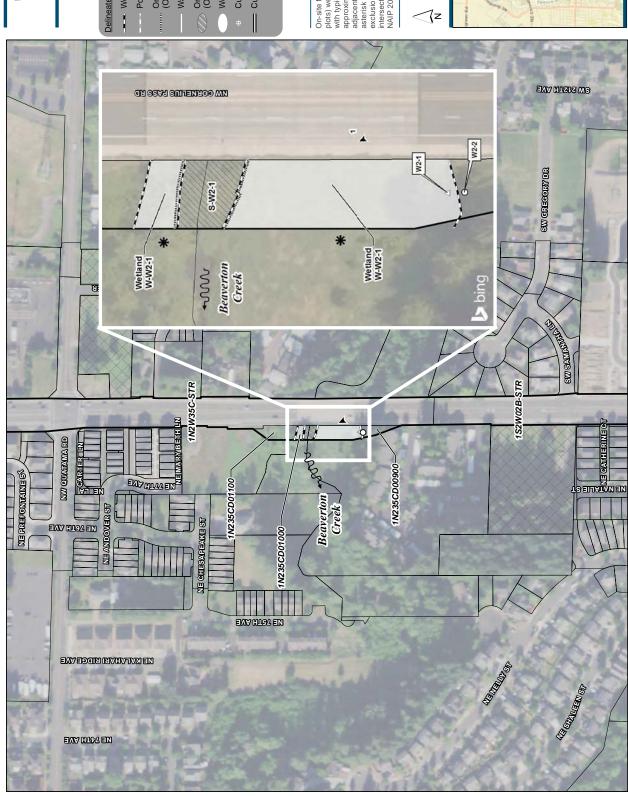
Figure 6, Sheet 4 of 9 Delineated Wetlands

On-site features (wetlands, ditches, streams, culverts, and data plots) were mapped with a Timble Pathifinder GEO XH receiver with hybical accuracy of 3 feet or better. Off-site boundaries are approximate and were mapped based on field review from adjacent public right of way and aerial photo interpretation. An asterisk was included where jurisdictional features, with the exclusion of upland ditches, extend off site. Only taxlots which intersect the study area are labeled. Imagery. USDA NAIP 2016; inset maps show Bing Maps Aerial imagery.

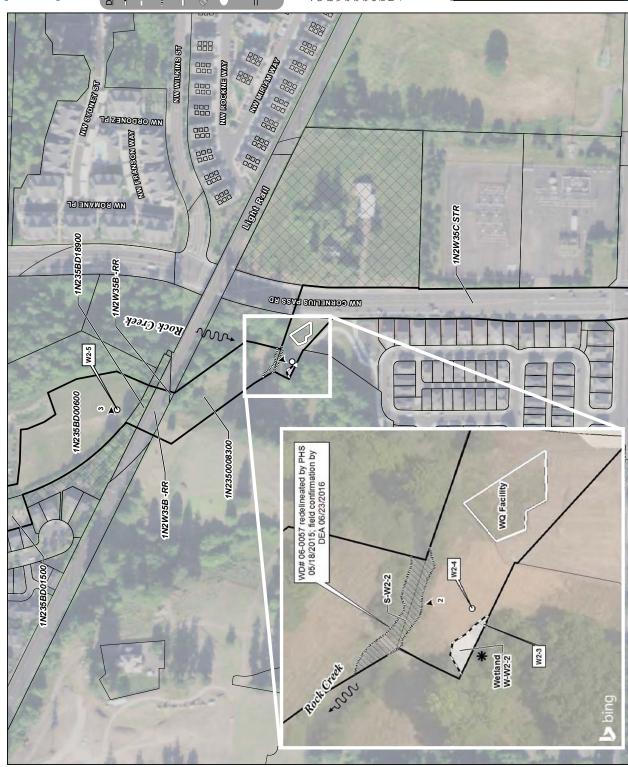
Figure 6, Sheet 5 of 9
Delineated Wetlands

On-site features (wetlands, ditches, streams, culverts, and data plots) were mapped with a Trimble Pathfinder GEO XH receiver with typical accuracy of 3 feet or behate. Off-site boundaries are approximate and were mapped based on field review from adjacent public right of way and aerial photo interpretation. An asterisk was included where jurisdictional features, with the acculsion of upland ditches, extend off site. Only taxlots which intersect the study area are labeled. Imageny: USDA NAIP 2016; inset maps show Bing Maps Aerial imageny.

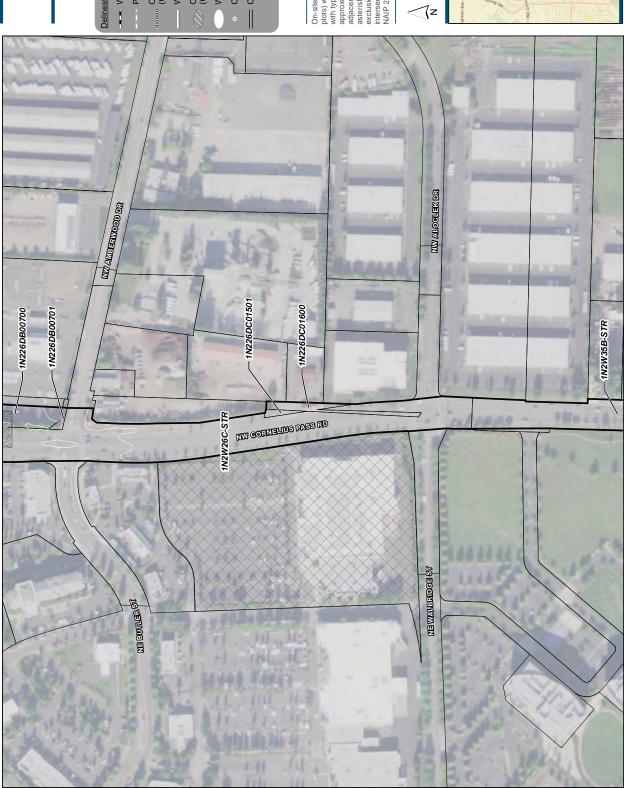
Figure 6, Sheet 7 of 9
Delineated Wetlands

On-site features (wetlands, ditches, streams, culverts, and data plots) were mapped with a Trimble Pathfinder GEO XH receiver with typical accuracy of 3 feet or betaer. Off-site boundaries are approximate and were mapped based on field review from adjacent public right of way and aerial photo interpretation. An asterisk was included where lurisdictional features, with the exclusion of upland ditches, extend off site. Only taxlots which intersect the study area are labeled. Imageny: USDA NAIP 2016; inset maps show Bing Maps Aerial imageny.

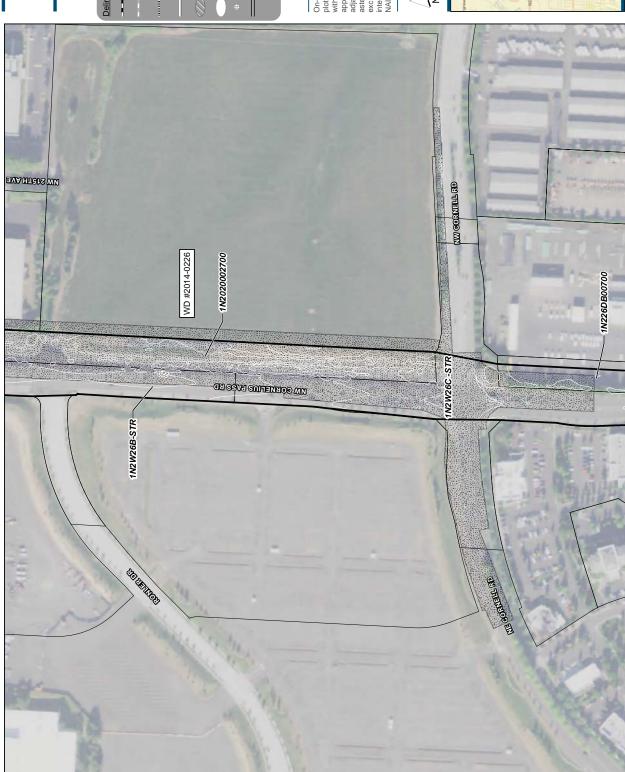
.w z.v) wetrand Delinea Figure 6, Sheet 8 of 9 Delineated Wetlands

On-site features (wetlands, ditches, streams, culverts, and data plots) were mapped with a Trimble Pathfinder GEO XH receiver with typical accuracy of 3 feet or better. Off-site boundaries are approximate and were mapped based on field review from adjacent public right of way and aerial photo interpretation. An asterisk was included where jurisdictional features, with the exclusion of upland ditches, axend off site. Only taxloss which intersect the study area are labeled. Imagery: USDA NAIP 2016; inset maps show Bing Maps Aerial imagery.

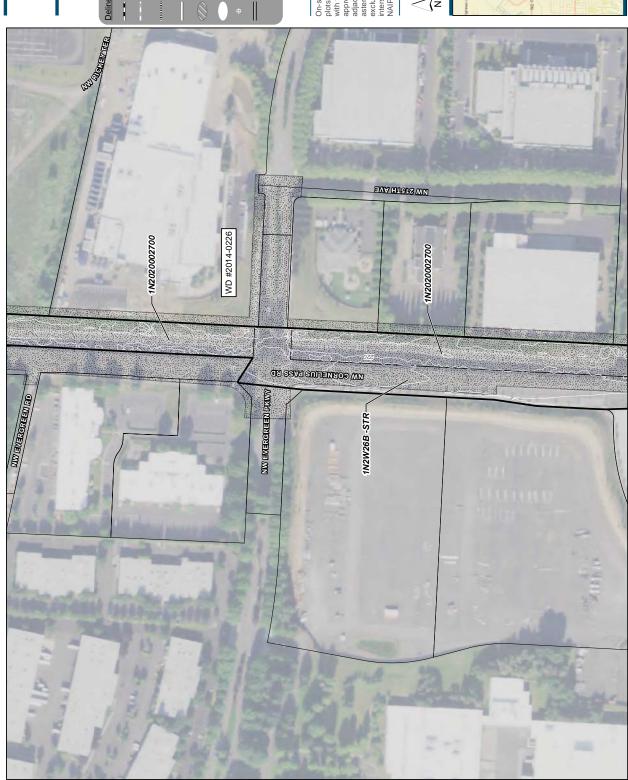
Ordinary High Water (OHW) Water Quality Facility Ordinary High Water (OHW) Area Potential Wetland == Culvert (approx) **Delineated Features** Wetland Area -- Wetland Culvert \sqrt{z} EL COLOR DE LA COL MW RICKEY TER Brian Bonson CONTISTING PROSECULOS IN THE PARTY OF THE PA 1N223000091 WD #2014-0226 1N2020002700 Wetland CornPass-E NW CORNELIUS PASS RD CornPass-C Wetland 1NZWZ3C -STR 1N2230001000-NW IMBRIEDR Wetland W-W2-3 W2-6 1N2230000910

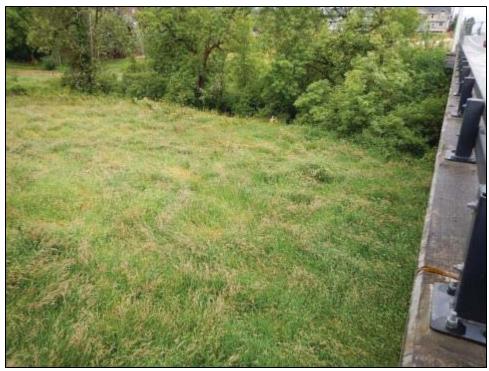
Photo 1: Looking northwest at wetland in floodplain above the OHWM of the incised Beaverton Creek. The OHWM lies at the top of bank where the surveyor is standing in the center of the photo (June 23, 2016).

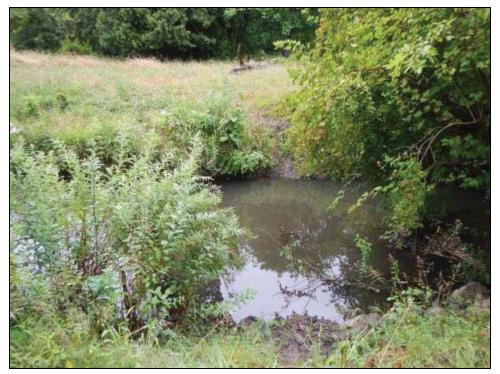
Photo 2: Looking north at Rock Creek from south bank (June 23, 2016). Scattered wetland vegetation is rooted below OHWM of creek with relatively steep sides. Delineated by PHS in 2015.

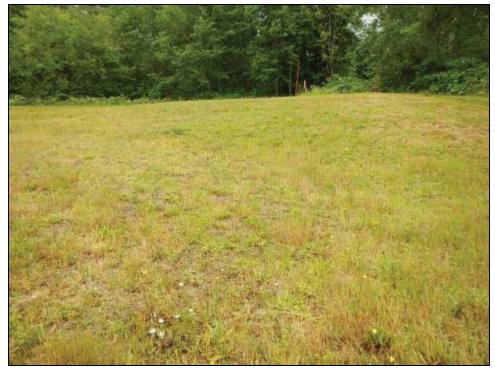
Photo 3: Looking east at level field north of Rock Creek and light rail tracks. June 23, 2016. As shown in Figure 6, potential wetlands mapped on the LWI lie east of the field at the base of the forested slope, and not within the study area.

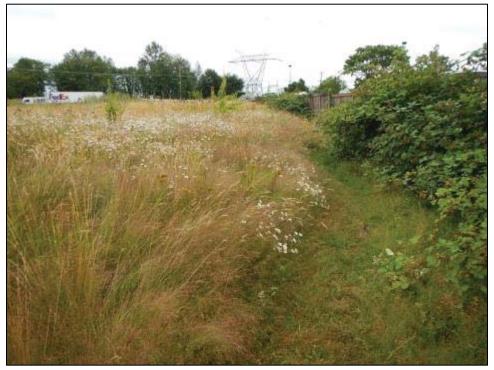
Photo 4: Looking southeast from the southern edge of the large, ruderal City of Hillsboro parcel. June 23, 2016.

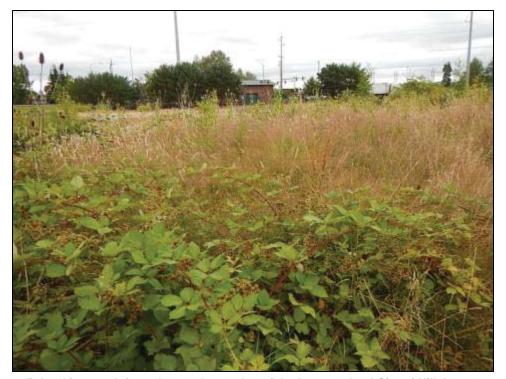
Photo 5: Looking north from the southern edge of the large, ruderal City of Hillsboro parcel. June 23, 2016.

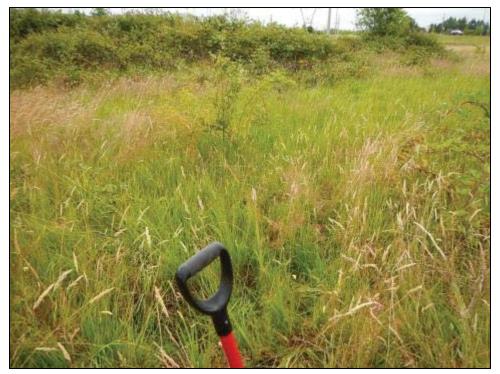
Photo 6: Looking north at wetland swale W2-3, with shallow slopes to either side. June 23, 2016.

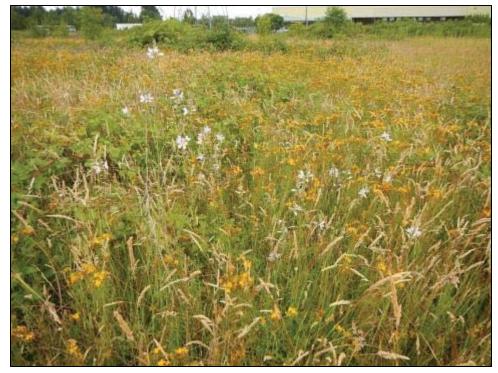
Photo 7: Looking south toward Fred Meyer Parking lot from upland area east of wetland. June 23, 2016. Note St. John's wort and meadow sidalcea mixed with other facultative grasses and blackberry.

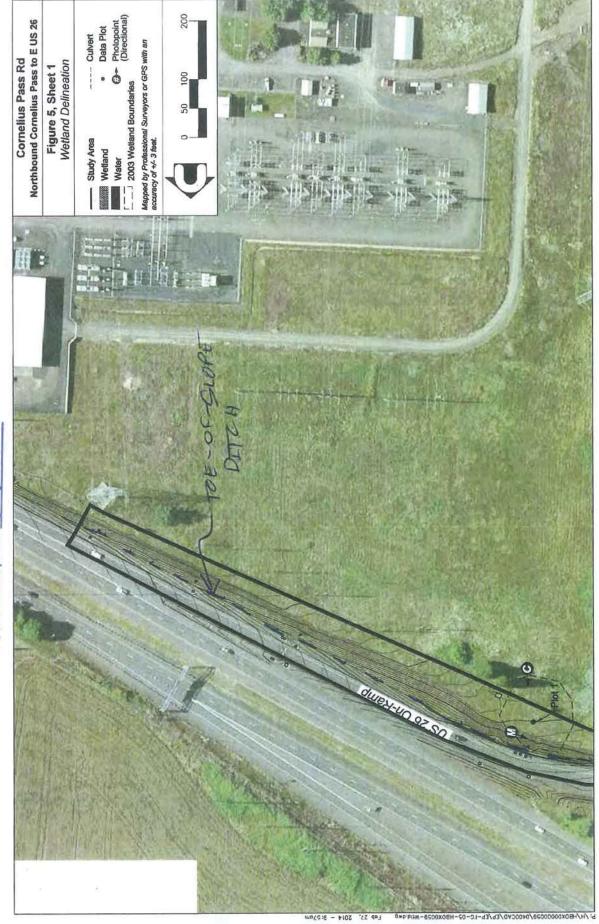
200 Cornelius Pass Rd Northbound Cornelius Pass to E US 26 Abandoned Relinged Grads Mapped by Professional Surveyors or GPS with an accuracy of +/- 3 feet. Figure 5, Sheet 2 Wetland Delineation - 1 2003 Wetland Boundaries Study Area Water NW Imbrie D Approval Expires 10-2 NW Comelius Pass Rd DE-OF-SOR

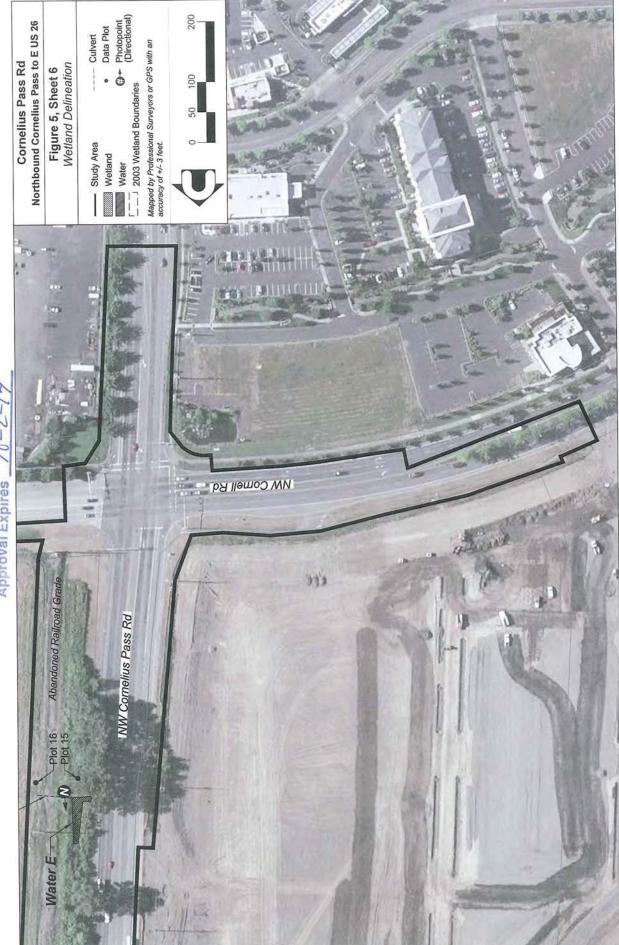
O+ Photopoint (Directional) Cornelius Pass Rd Northbound Cornelius Pass to E US 26 Culvert
 Data Plot Mapped by Professional Surveyors or GPS with an accuracy of +/- 3 feet. Figure 5, Sheet 5 Wetland Delineation Z003 Wetland Boundaries Study Area Wetland Water NW Cornell Rd Abandoned Railroad Grade 61-2-01 NW Cornelius Pass Rd Approval Expires Plot 16 Plot 15 Culvert (approx. location) Water E 1N2020002700 Feb 27.
